BMP Prioritization Matrix for Potential Areas of Concern
Pomperaug River Watershed Based Plan

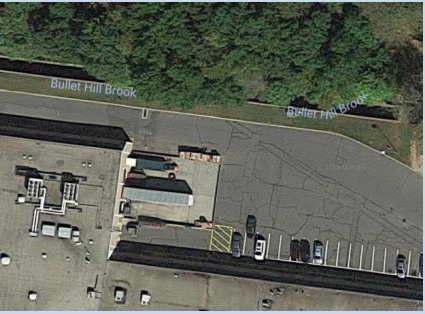
| New Site ID (Impaired Segment) | Location Description | Bacteria Sources | Potential Best Management Practices (BMPs) | Other Recommendations and Notes | Relative BMP Pollutant (Bacteria) Removal | Relative Cost | Maintenance Requirements | Field Visit Conducted | BMP Concept Development | Photo |
|---|--|---|---|---|--|---|---|---|---|---|
| Commercial Complex 1 (tributary to Pomperaug-03) | East side of intersection of Route 6 and Main Street South, Southbury (South of Bullet Hill Brook) | Stormwater runoff, waste management, past septic issues | <ul style="list-style-type: none"> Incorporate LID retrofits into site redevelopment Underground infiltration, permeable pavement Inspect septic systems for failure (due to size this falls under DPH or DEEP jurisdiction) | <ul style="list-style-type: none"> Cover dumpsters with roof Review stormwater control plan, if exists Heavily channelized stream Conduct survey for potential illicit discharges from businesses in plaza | High | High | High | Yes | | |

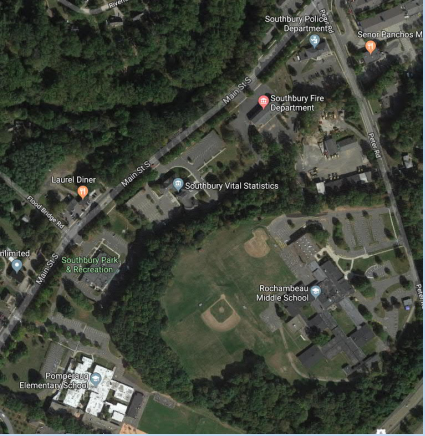
| New Site ID (Impaired Segment) | Location Description | Bacteria Sources | Potential Best Management Practices (BMPs) | Other Recommendations and Notes | Relative BMP Pollutant (Bacteria) Removal | Relative Cost | Maintenance Requirements | Field Visit Conducted | BMP Concept Development | Photo |
|---|--|---|---|---|--|---|---|---|---|---|
| Business District 1 (Pomperaug-03) | Main Street South Corridor, Southbury (particularly concentrated at Municipal Complex west of the intersection with Peter Road | Stormwater runoff | <ul style="list-style-type: none"> Develop and implement GI/LID "master plan" for Main Street South corridor LID retrofits of municipal and commercial properties and within the municipal ROW between Route 6/Southbury Plaza and South Britain Road (Route 172) Potential municipal sites include: <ul style="list-style-type: none"> Southbury Police, Fire, and DPW Southbury Town Hall Southbury Park and Recreation Rochambeau Middle School Pomperaug Elementary School Southbury Library Municipal ROW Numerous commercial redevelopment sites along the corridor | | High | High | High | Yes | | |

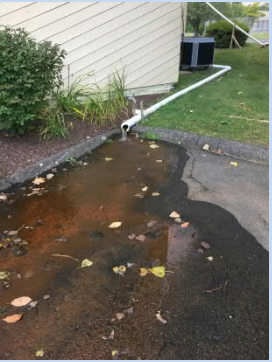
| New Site ID (Impaired Segment) | Location Description | Bacteria Sources | Potential Best Management Practices (BMPs) | Other Recommendations and Notes | Relative BMP Pollutant (Bacteria) Removal | Relative Cost | Maintenance Requirements | Field Visit Conducted | BMP Concept Development | Photo |
|---|--|---|---|---|--|---|---|---|---|---|
| Health Care 2 (tributary to Pomperaug-03) | Intersection of Main Street South and Garage Road | Dry weather discharge (pavement stained) | <ul style="list-style-type: none"> Follow up sampling of dry weather discharge and removal of any illicit connections found | | Medium | Low | Low | Yes | | |

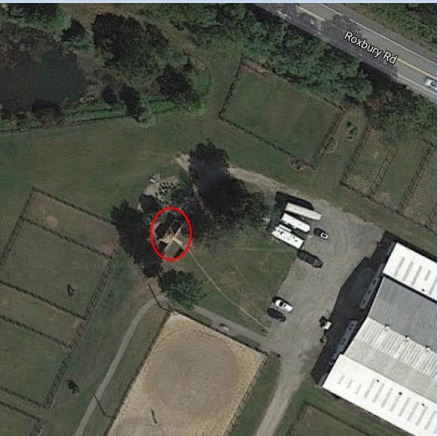
| New Site ID (Impaired Segment) | Location Description | Bacteria Sources | Potential Best Management Practices (BMPs) | Other Recommendations and Notes | Relative BMP Pollutant (Bacteria) Removal | Relative Cost | Maintenance Requirements | Field Visit Conducted | BMP Concept Development | Photo |
|---|---|---|---|--|--|---|---|---|---|---|
| Equestrian 4 | Intersection of Route 67 and Crook Horn Drive | Manure in open dumpsters | <ul style="list-style-type: none"> Cover dumpsters or ensure drainage away from river | <ul style="list-style-type: none"> Outreach for manure management best practices | High | Low | Low | Yes | | |

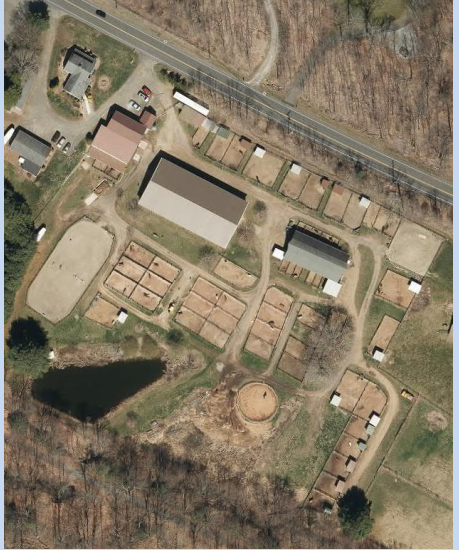
| New Site ID (Impaired Segment) | Location Description | Bacteria Sources | Potential Best Management Practices (BMPs) | Other Recommendations and Notes | Relative BMP Pollutant (Bacteria) Removal | Relative Cost | Maintenance Requirements | Field Visit Conducted | BMP Concept Development | Photo |
|--|---|--|---|---|--|---|---|---|---|---|
| Equestrian 3 | Route 67 along South Branch of Bullet Hill Brook | Stream running through paddock | <ul style="list-style-type: none"> Encourage sufficient buffer Animal exclusion fencing | | | | | No | | |

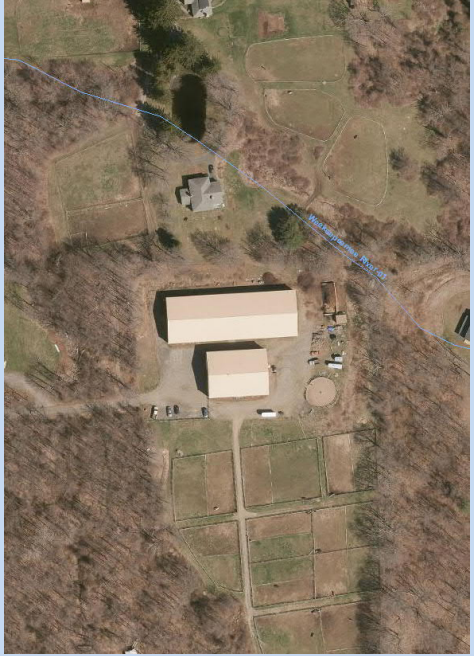
| New Site ID (Impaired Segment) | Location Description | Bacteria Sources | Potential Best Management Practices (BMPs) | Other Recommendations and Notes | Relative BMP Pollutant (Bacteria) Removal | Relative Cost | Maintenance Requirements | Field Visit Conducted | BMP Concept Development | Photo |
|---|---|---|---|--|--|---|---|---|---|---|
| Equestrian 6 | east of Todd Hill Road, south of Bergman Hill Road, Bethlehem | Manure storage | <ul style="list-style-type: none"> Encourage effective manure management | <ul style="list-style-type: none"> Evaluate manure storage Outreach for manure management best practices | | | | No | | |

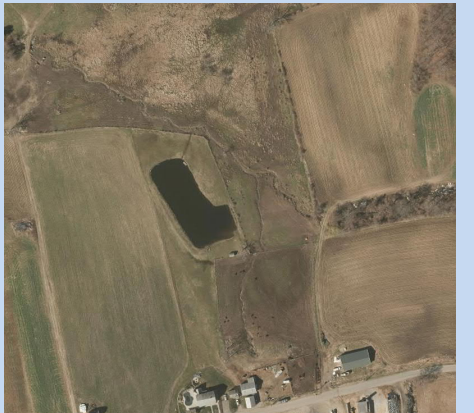
| New Site ID (Impaired Segment) | Location Description | Bacteria Sources | Potential Best Management Practices (BMPs) | Other Recommendations and Notes | Relative BMP Pollutant (Bacteria) Removal | Relative Cost | Maintenance Requirements | Field Visit Conducted | BMP Concept Development | Photo |
|---|---|---|---|--|--|---|---|---|---|---|
| Dairy Farm 2 | Artillery Road, Woodbury | Livestock access to tributary. Incomplete coverage of manure storage. | <ul style="list-style-type: none"> Filter berms or fencing and increased buffer around stream to prevent livestock access Reconfigure manure composting to divert runoff away from catch basins Consider covered manure storage or manure composting | | High | Medium | Low | Yes | | |

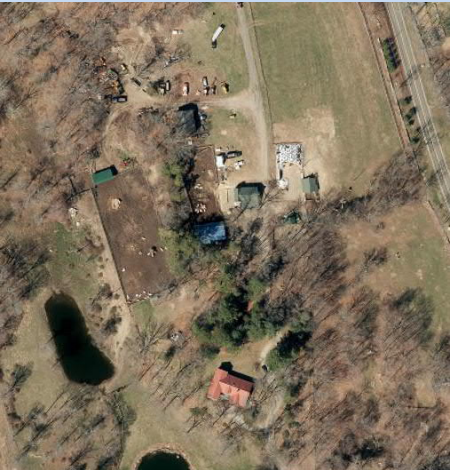
| New Site ID (Impaired Segment) | Location Description | Bacteria Sources | Potential Best Management Practices (BMPs) | Other Recommendations and Notes | Relative BMP Pollutant (Bacteria) Removal | Relative Cost | Maintenance Requirements | Field Visit Conducted | BMP Concept Development | Photo |
|---|--|--|---|---|--|---|---|---|---|---|
| Livestock 7 | West side of Flanders Road near intersection with Church Hill Road, Woodbury | Cattle | <ul style="list-style-type: none"> Encourage effective manure management | <ul style="list-style-type: none"> Outreach for manure management best practices | | | | No | | |

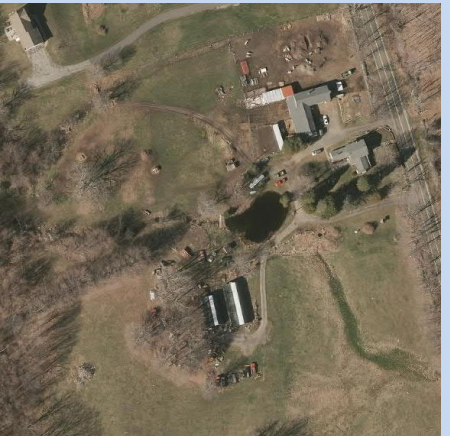
| New Site ID (Impaired Segment) | Location Description | Bacteria Sources | Potential Best Management Practices (BMPs) | Other Recommendations and Notes | Relative BMP Pollutant (Bacteria) Removal | Relative Cost | Maintenance Requirements | Field Visit Conducted | BMP Concept Development | Photo |
|---|--|--|---|---|--|---|---|---|---|---|
| Livestock 6 | West side of Flanders Road near intersection with Church Hill Road, Woodbury | Cattle, chickens, pigs, etc | <ul style="list-style-type: none"> Encourage effective manure management | <ul style="list-style-type: none"> Outreach for manure management best practices | | | | No | | |

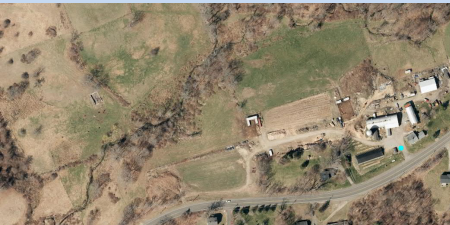
| New Site ID (Impaired Segment) | Location Description | Bacteria Sources | Potential Best Management Practices (BMPs) | Other Recommendations and Notes | Relative BMP Pollutant (Bacteria) Removal | Relative Cost | Maintenance Requirements | Field Visit Conducted | BMP Concept Development | Photo |
|---|--|--|---|---|--|---|---|---|---|---|
| Livestock 5 | Route 6 near Guernseytown Road on the Woodbury/Watert own townline | Cattle, chickens, pigs, etc | <ul style="list-style-type: none"> Encourage effective manure management | <ul style="list-style-type: none"> Outreach for manure management best practices | | | | No | | |

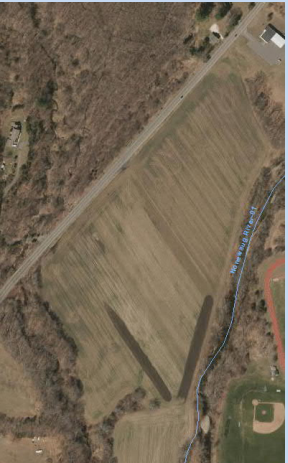
| New Site ID (Impaired Segment) | Location Description | Bacteria Sources | Potential Best Management Practices (BMPs) | Other Recommendations and Notes | Relative BMP Pollutant (Bacteria) Removal | Relative Cost | Maintenance Requirements | Field Visit Conducted | BMP Concept Development | Photo |
|---|--|--|---|---|--|---|---|---|---|---|
| Cropland 3 | East of Main Street North (Route 6), north of Scratchville Road along Nonnewaug River | Cornfield – application of manure as fertilizer | <ul style="list-style-type: none"> Encourage effective application strategies and timing Enhance width of riparian buffer | | | | | No | | |

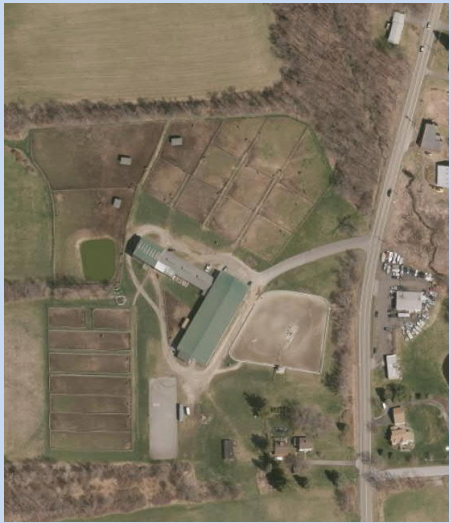
| New Site ID (Impaired Segment) | Location Description | Bacteria Sources | Potential Best Management Practices (BMPs) | Other Recommendations and Notes | Relative BMP Pollutant (Bacteria) Removal | Relative Cost | Maintenance Requirements | Field Visit Conducted | BMP Concept Development | Photo |
|---|---|---|---|---|--|---|---|---|---|--|
| Equestrian 7 | Route 61, Morris north of fairgrounds | Manure storage | <ul style="list-style-type: none"> Increase buffer to stream | <ul style="list-style-type: none"> Manure management measures appear to be in place Outreach for manure management best practices Connecticut Horse Environmental Awareness Program (HEAP) and Connecticut Horse Farm of Environmental Distinction Program | High | Low | Low | Yes | | |

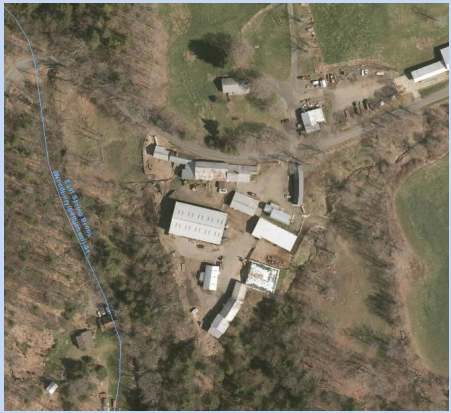
| New Site ID (Impaired Segment) | Location Description | Bacteria Sources | Potential Best Management Practices (BMPs) | Other Recommendations and Notes | Relative BMP Pollutant (Bacteria) Removal | Relative Cost | Maintenance Requirements | Field Visit Conducted | BMP Concept Development | Photo |
|---|---|---|---|---|--|---|---|---|---|--|
| Dairy Farm 3 | Magnolia Hill Road and Hard Hill Road South, Bethlehem | Livestock access to tributary. Manure storage | <ul style="list-style-type: none"> Filter berms or fencing and increased buffer around stream to prevent livestock access Evaluate manure storage practices | <ul style="list-style-type: none"> Outreach for manure management best practices | | | | No | | |

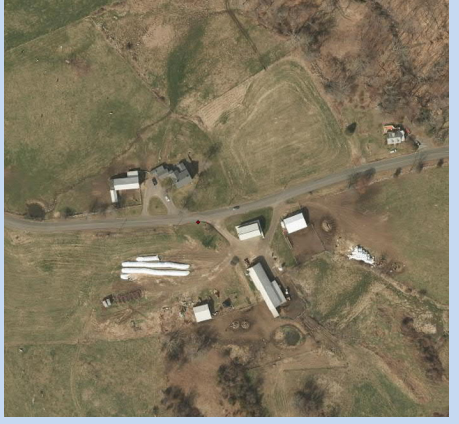
| New Site ID (Impaired Segment) | Location Description | Bacteria Sources | Potential Best Management Practices (BMPs) | Other Recommendations and Notes | Relative BMP Pollutant (Bacteria) Removal | Relative Cost | Maintenance Requirements | Field Visit Conducted | BMP Concept Development | Photo |
|---|--|---|--|---|--|---|---|---|---|---|
| Dairy Farm 4 | Spruce Brook Road, Southbury | Manure storage | <ul style="list-style-type: none"> Encourage effective manure management | <ul style="list-style-type: none"> Outreach for manure management best practices | | | | No | | |

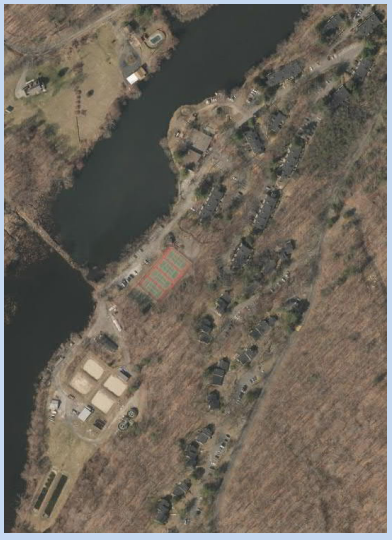
| New Site ID (Impaired Segment) | Location Description | Bacteria Sources | Potential Best Management Practices (BMPs) | Other Recommendations and Notes | Relative BMP Pollutant (Bacteria) Removal | Relative Cost | Maintenance Requirements | Field Visit Conducted | BMP Concept Development | Photo |
|---|--|---|--|---|--|---|---|---|---|---|
| Residential Complex 4 | Transylvania Road & Woodlake Road | Private sewage treatment plant | <ul style="list-style-type: none"> Ensure correct sizing and effective monitoring for failures | | | | | No | | |

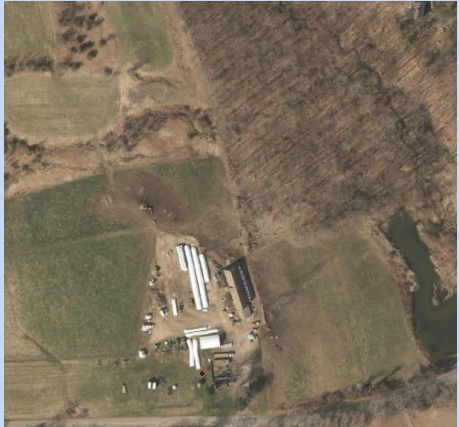
| New Site ID (Impaired Segment) | Location Description | Bacteria Sources | Potential Best Management Practices (BMPs) | Other Recommendations and Notes | Relative BMP Pollutant (Bacteria) Removal | Relative Cost | Maintenance Requirements | Field Visit Conducted | BMP Concept Development | Photo |
|---|--|---|--|---|--|---|---|---|---|---|
| Dairy Farm 5 | north of intersection of Grassy Hill Road and North Road, Woodbury | Manure storage / Cattle pastured on slope draining to pond with minimal buffer width | <ul style="list-style-type: none"> Filter berms or fencing and increased buffer around stream to prevent livestock access | <ul style="list-style-type: none"> Outreach for manure management best practices | | | | No | | |
